K-145

Mitchell Home Farm Kentmore Park 2nd Quarter 19th Century

Maryland Historical Trust State Historic Sites Inventory Form

HISTORIC AMERICAN BUILDINGS SURVEY INVENTORY K-145

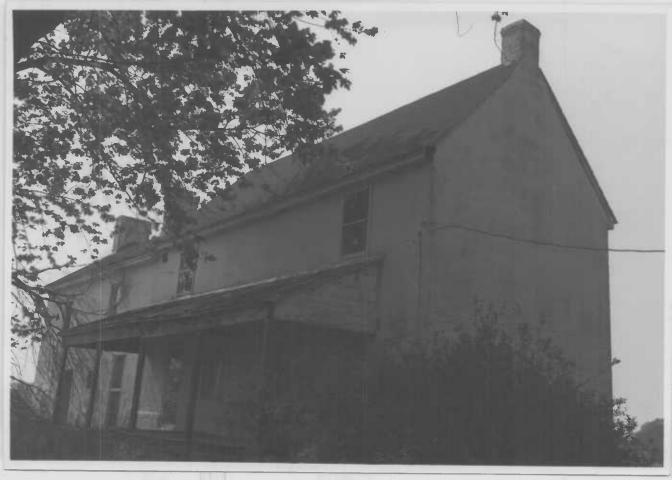
K-145
Roy Mitchell Home Farm
Rt. 444, near Locust Grove
M. Q. Fallaw - 4/23/85
View to northwest

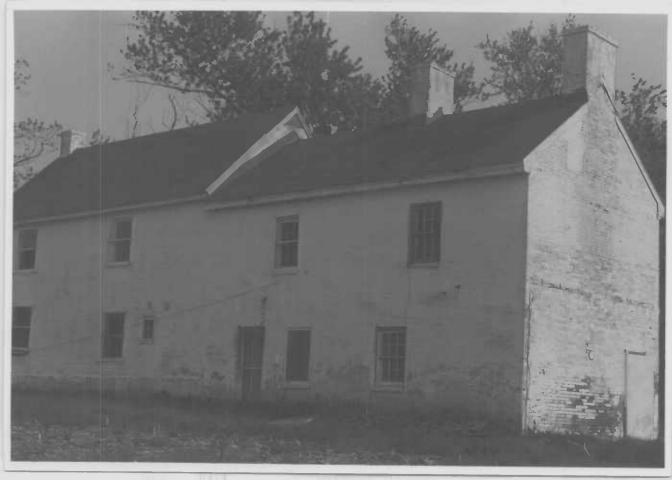
K-145
Roy Mitchell Home Farm
Rt. 444, near Locust Grove
M. Q. Fallaw - 4/23/85
View to southeast
